**Flood Control Project Maintenance
Levee Inspections**
LMA District Cover Sheet
Spring 2017 Levee Inspection Results

Reclamation District No. 1601 Twitchell

Levee Inspection Report By Mile - Spring 2017

Waterway	Bank	Unit Miles	Inspection Start/End	Inspector
Unit No. 01 Threemile Slough	Left	2.43	03/15/2017 03/15/2017	Richard Willoughby

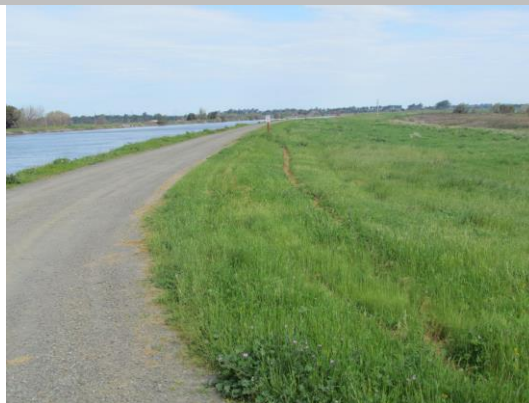
Photo 1 of 1 : SP_2017_RD1601_237_11_20170316_00020.jpg

LM Start	0.00	Rating **	M	Issue No.	11
LM End	2.42	Issue Type +	Ma	Location *	LS
Category	Earthen Levee			GPS Latitude/Longitude	
				Start	End
Item	Vegetation			38.122258 °	38.087665 °
				-121.682557 °	-121.683875 °
DWR ID	DWR_RD1601_01_s_2017_11				
Comment Code					
V1 : Control annual grass and weeds on the levee slopes and easements.					
Inspector Comment

Looking northwest at typical view of landward slope.

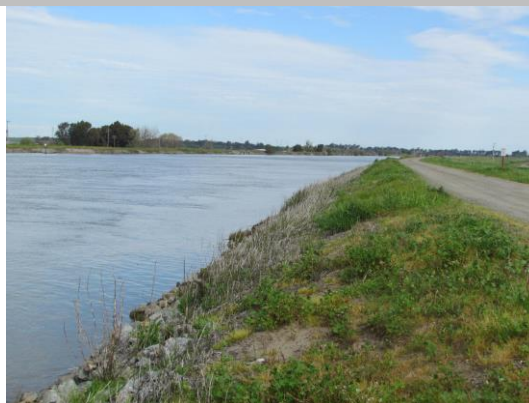
Photo 1 of 1 : SP_2017_RD1601_237_12_20170316_00019.jpg

LM Start	0.00	Rating **	M	Issue No.	12
LM End	2.42	Issue Type +	Ma	Location *	WS
Category	Earthen Levee			GPS Latitude/Longitude	
				Start	End
Item	Vegetation			38.122258 °	38.087665 °
				-121.682557 °	-121.683875 °
DWR ID	DWR_RD1601_01_s_2017_12				
Comment Code					
V1 : Control annual grass and weeds on the levee slopes and easements.					
Inspector Comment

Looking northwest at typical view of waterward slope.

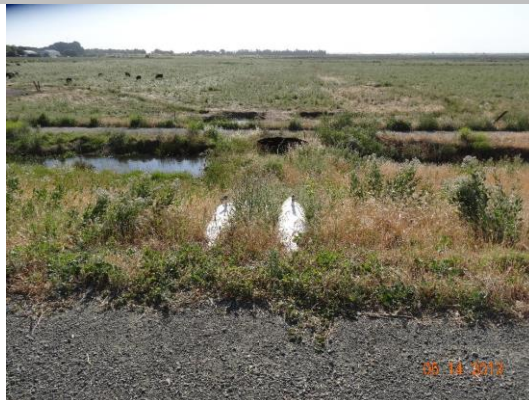
Photo 2 of 3 : UCIP_SP_2017_22043_37622.jpg

View of landward side with canal located at toe.

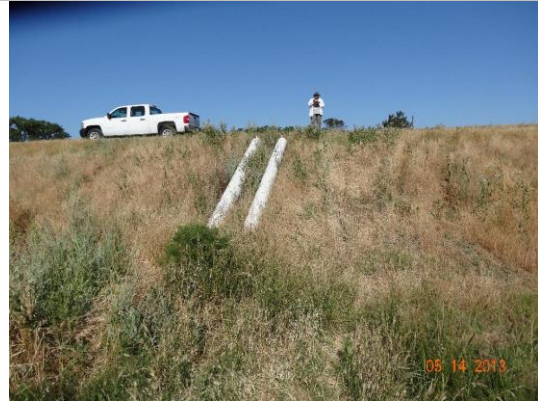
Photo 3 of 3 : UCIP_SP_2017_22043_37624.jpg

Comment Code						
Inspector Comment						
FS_ID:22043 DS_ID:20950 EP_NO: 11227 Repair Type: Non-Urgent Crossing Status: Found UCIP Comments: Appears this crossing might be been recently modified--exposed section of pipe is protected with white paint. Need to contact owner to obtain records. Recommend clearing vegetation along the pipe alignment. FIELD_STRUCT_DESC: 14-inch pipe (not 12-inch pipe as original description noted) through the levee, 4.0 feet below the crown. Siphon primer on waterward shoulder. 36-inch steel (not concrete as original description noted) pipe with shut-off valve inside at landward toe ditch. (ABO No. 11227-1975) FS Date: 5/14/2013

View of pipes located on landward side-dense vegetation along slope.

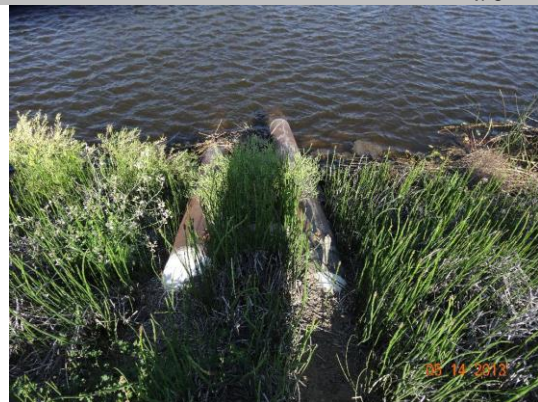
Photo 1 of 3 : UCIP_SP_2017_42024_60809.jpg

Comment Code					
Inspector Comment					
FS_ID:42024 DS_ID:20953 EP_NO: N/A Repair Type: Non-Urgent Crossing Status: Found UCIP Comments: Appears this crossing might have been recently modified--O&M manual calls for 8 inch pipe not 12 inch pipe, need additional information--exposed section of pipe is protected with white paint. Need to contact owner to obtain records. Recommend clearing vegetation along the pipe alignment. FIELD_STRUCT_DESC: 12-inch (not 8 inch listed in USACE) siphon through the levee approximately 3.2 feet below the crown. The existing 8-inch pipe listed in the O&M manual is no longer present at LM 0.1 (USACE-1959), no permit was found authorizing crossing modifications. FS Date: 5/14/2013

View of waterward side. 12-inch pipe on the right (u/s) and 14-inch pipe on the left (d/s).

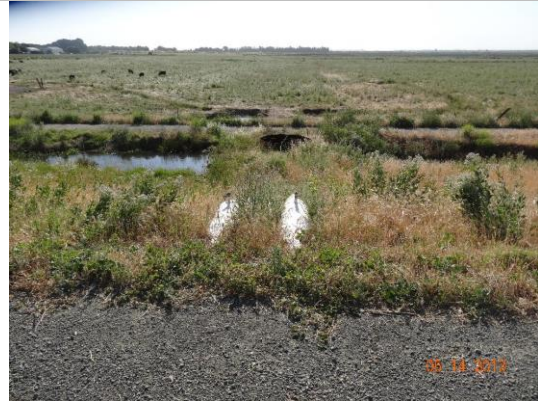
Photo 2 of 3 : UCIP_SP_2017_42024_60810.jpg

Comment Code						
Inspector Comment						
FS_ID:42024						
DS_ID:20953						
EP_NO: N/A						
Repair Type: Non-Urgent						
Crossing Status: Found						
UCIP Comments: Appears this crossing might have been recently modified--O&M manual calls for 8 inch pipe not 12 inch pipe, need additional information--exposed section of pipe is protected with white paint. Need to contact owner to obtain records. Recommend clearing vegetation along the pipe alignment.						
FIELD_STRUCT_DESC: 12-inch (not 8 inch listed in USACE) siphon through the levee approximately 3.2 feet below the crown. The existing 8-inch pipe listed in the O&M manual is no longer present at LM 0.1 (USACE-1959), no permit was found authorizing crossing modifications.						
FS Date: 5/14/2013

View of pipes from landward shoulder. Levee is a gravel road.

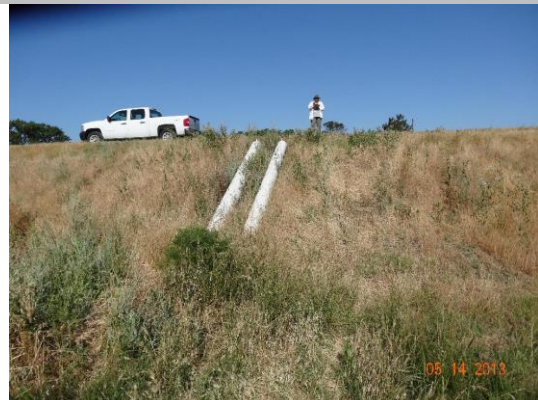
Photo 3 of 3 : UCIP_SP_2017_42024_60812.jpg

View of pipes on landward side-dense vegetation along slope.

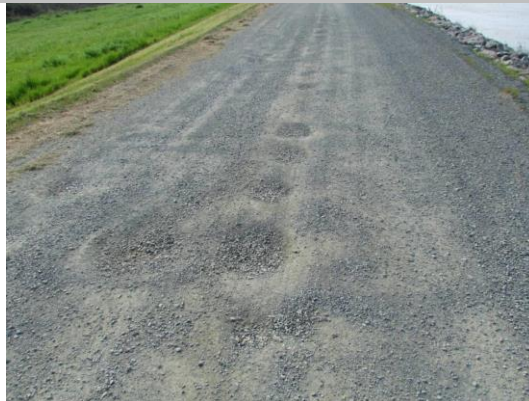
Photo 1 of 2 : SP_2017_RD1601_237_13_20170316_00021.jpg

LM Start	0.18	Rating **	M	Issue No.	13
LM End	2.42	Issue Type +	Ma	Location *	CR
Category	Earthen Levee			GPS Latitude/Longitude	
				Start	End
Item	Crown Surface / Depressions / Rutting			38.119757 °	38.087665 °
				-121.682892 °	-121.683875 °
DWR ID	DWR_RD1601_01_s_2017_13				
Comment Code					
C2 : Repair depressions or ruts in the crown or slope.					
Inspector Comment					
Control ruts and regrade levee crown.

Looking south at typical view of ruts on levee crown.

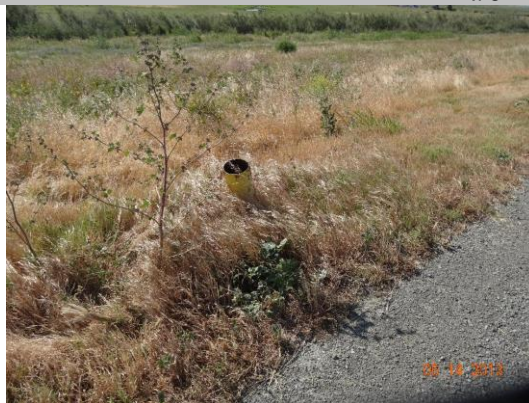
Photo 1 of 3 : UCIP_SP_2017_39946_71862.jpg

LM Start	0.79	Rating **	M	Issue No.	17
LM End	0.79	Issue Type +	En	Location *	CR
Category	Supplemental			GPS Latitude/Longitude	
				Start	End
Item	DWR UCIP Field Study			38.111078 °	38.111078 °
				-121.682011 °	-121.682011 °
DWR ID					
Comment Code					
Inspector Comment					
FS_ID:39946 DS_ID:24069 EP_NO: N/A Repair Type: Non-Urgent Crossing Status: Indicator Found UCIP Comments: Unable to determine if line crosses levee. Need to contact owner to determine if crossing goes through levee. Also need to determine permit authorizing work on landward side. FIELD_STRUCT_DESC: Steel stand pipe with PVC pipe inside located on landward shoulder. Rip rap located on waterward slope. Unable to determine if crossing goes through levee. Appears to be monitoring gas well. FS Date: 3/19/2009

View of landward side--standpipe located on slope.

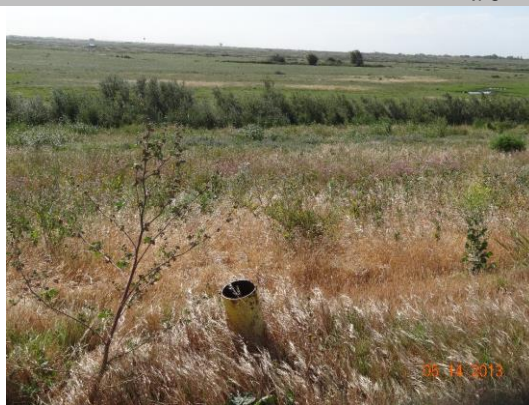
Photo 2 of 3 : UCIP_SP_2017_39946_71860.jpg

View of landward side--dense vegetation along slope.

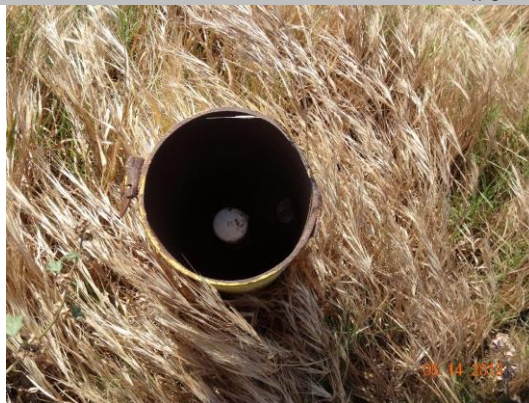
Photo 3 of 3 : UCIP_SP_2017_39946_71861.jpg

LM Start	0.79	Rating **	M	Issue No.	17 (cont)	
LM End	0.79	Issue Type +	En	Location *	CR	
Category	Supplemental			GPS Latitude/Longitude		
				Start		End
Item	DWR UCIP Field Study			38.111078 °		38.111078 °
				-121.682011 °		-121.682011 °
DWR ID						
Comment Code						
Inspector Comment						
FS_ID:39946 DS_ID:24069 EP_NO: N/A Repair Type: Non-Urgent Crossing Status: Indicator Found UCIP Comments: Unable to determine if line crosses levee. Need to contact owner to determine if crossing goes through levee. Also need to determine permit authorizing work on landward side. FIELD_STRUCT_DESC: Steel stand pipe with PVC pipe inside located on landward shoulder. Rip rap located on waterward slope. Unable to determine if crossing goes through levee. Appears to be monitoring gas well. FS Date: 3/19/2009

PVC pipe inside standpipe located on landward side.

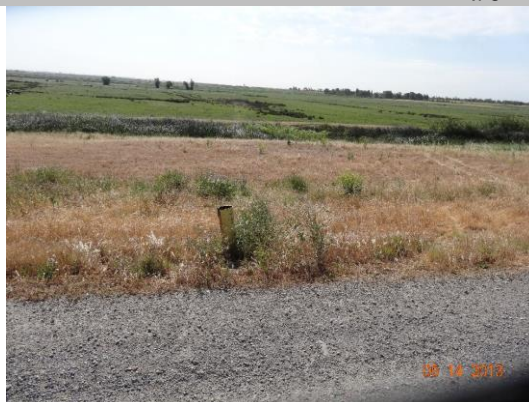
Photo 1 of 3 : UCIP_SP_2017_39947_71865.jpg

LM Start	1.40	Rating **	M	Issue No.	18
LM End	1.40	Issue Type +	En	Location *	CR
Category	Supplemental			GPS Latitude/Longitude	
				Start	End
Item	DWR UCIP Field Study			38.102422 °	38.102422 °
				-121.684289 °	-121.684289 °
DWR ID					
Comment Code					
Inspector Comment					
FS_ID:39947 DS_ID:24068 EP_NO: N/A Repair Type: Non-Urgent Crossing Status: Indicator Found UCIP Comments: Unable to determine if line crosses levee. Need to contact owner to determine if crossing goes through levee. Also need to determine permit authorizing work on landward side. FIELD_STRUCT_DESC: Steel stand pipe with PVC pipe inside located on landward shoulder. Rip rap located on waterward slope. Unable to determine if crossing goes through levee. Appears to be monitoring gas well. FS Date: 3/19/2009

View of landward side.

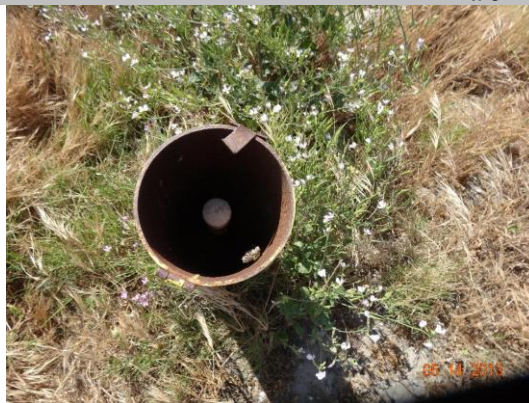
Photo 2 of 3 : UCIP_SP_2017_39947_71866.jpg

LM Start	1.40	Rating **	M	Issue No.	18 (cont)	
LM End	1.40	Issue Type +	En	Location *	CR	
Category	Supplemental			GPS Latitude/Longitude		
				Start		End
Item	DWR UCIP Field Study			38.102422 °		38.102422 °
				-121.684289 °		-121.684289 °
DWR ID						
Comment Code						
Inspector Comment						
FS_ID:39947 DS_ID:24068 EP_NO: N/A Repair Type: Non-Urgent Crossing Status: Indicator Found UCIP Comments: Unable to determine if line crosses levee. Need to contact owner to determine if crossing goes through levee. Also need to determine permit authorizing work on landward side. FIELD_STRUCT_DESC: Steel stand pipe with PVC pipe inside located on landward shoulder. Rip rap located on waterward slope. Unable to determine if crossing goes through levee. Appears to be monitoring gas well. FS Date: 3/19/2009

PVC inside standpipe located on landward side.

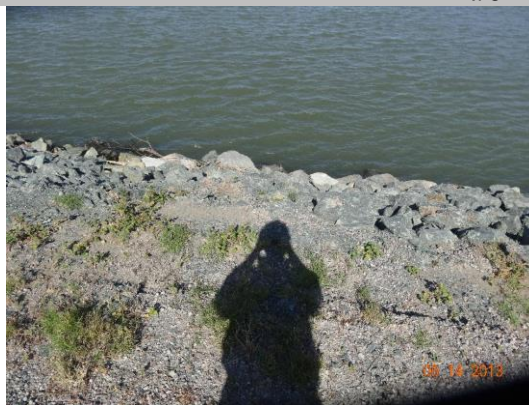
Photo 3 of 3 : UCIP_SP_2017_39947_71864.jpg

View of waterward side -- rip rap located along waterward toe.

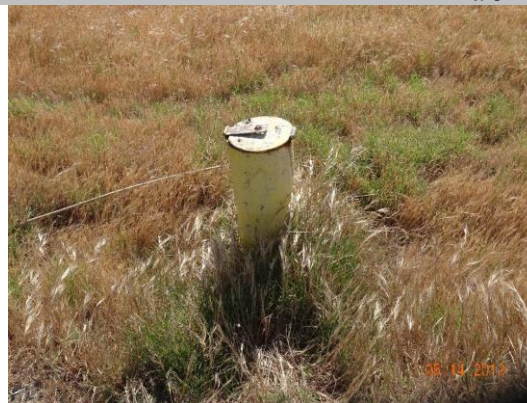
Photo 1 of 3 : UCIP_SP_2017_39948_71869.jpg

LM Start	1.77	Rating **	M	Issue No.	19
LM End	1.77	Issue Type +	En	Location *	CR
Category	Supplemental			GPS Latitude/Longitude	
				Start	End
Item	DWR UCIP Field Study			38.097105 °	38.097105 °
				-121.684815 °	-121.684815 °
DWR ID					
Comment Code					
Inspector Comment					
FS_ID:39948 DS_ID:24071 EP_NO: N/A Repair Type: Non-Urgent Crossing Status: Indicator Found UCIP Comments: Unable to determine if line crosses levee. Need to contact owner to determine if crossing goes through levee. Also need to determine permit authorizing work on landward side. FIELD_STRUCT_DESC: Steel stand pipe with PVC pipe inside located on landward shoulder. Rip rap located on waterward slope. Unable to determine if crossing goes through levee. Appears to be monitoring gas well. FS Date: 3/19/2009

Standpipe located on landward side.

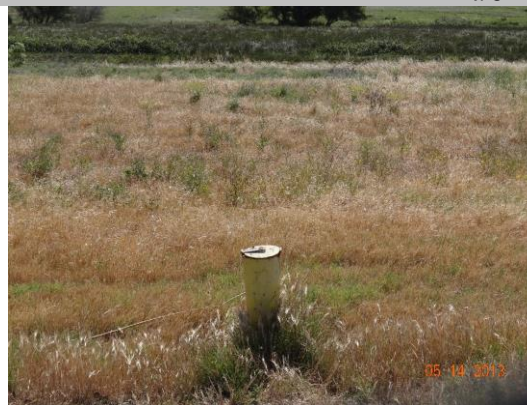
Photo 2 of 3 : UCIP_SP_2017_39948_71868.jpg

View of landward side.

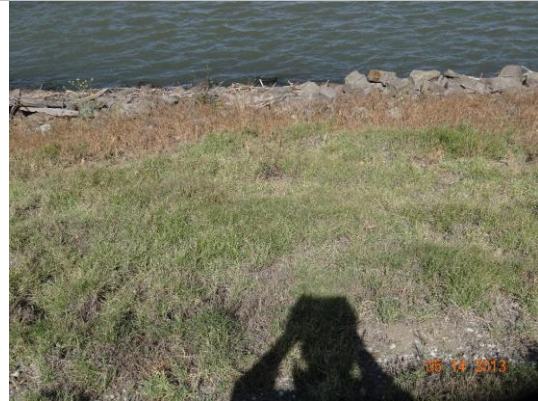
Photo 3 of 3 : UCIP_SP_2017_39948_71867.jpg

LM Start	1.77	Rating **	M	Issue No.	19 (cont)
LM End	1.77	Issue Type +	En	Location *	CR
Category	Supplemental			GPS Latitude/Longitude	
				Start	End
Item	DWR UCIP Field Study			38.097105 °	38.097105 °
				-121.684815 °	-121.684815 °
DWR ID					
Comment Code					
Inspector Comment					
FS_ID:39948 DS_ID:24071 EP_NO: N/A Repair Type: Non-Urgent Crossing Status: Indicator Found UCIP Comments: Unable to determine if line crosses levee. Need to contact owner to determine if crossing goes through levee. Also need to determine permit authorizing work on landward side. FIELD_STRUCT_DESC: Steel stand pipe with PVC pipe inside located on landward shoulder. Rip rap located on waterward slope. Unable to determine if crossing goes through levee. Appears to be monitoring gas well. FS Date: 3/19/2009

View of waterward side.

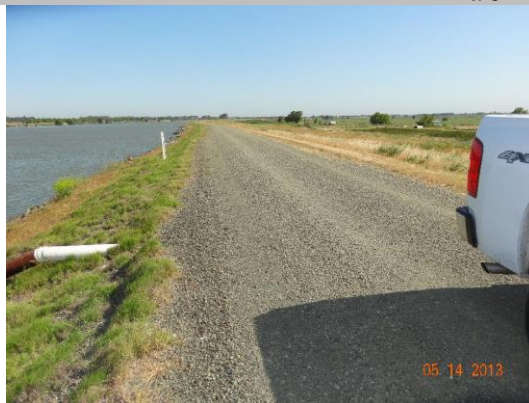
Photo 2 of 3 : UCIP_SP_2017_19545_33174.jpg

Comment Code						
Inspector Comment						
FS_ID:19545 DS_ID:20951 EP_NO: 2909A Repair Type: Non-Urgent Crossing Status: Found UCIP Comments: Appears this crossing might be been recently modified--exposed section of pipe is protected with white paint. Need to contact owner to obtain records. Recommend clearing vegetation along the pipe alignment. Dense vegetation on landward slope limits the inspector's visibility to identify signs of leaks along levee slope. FIELD_STRUCT_DESC: 8-inch siphon pipe through levee, 2.4 feet below crown. Cutoff wall around pipe at center of levee. Siphon breaker on apex of pipe on landward shoulder. Hand primer pump on landward slope. (Permit No. 2909A-1960) FS Date: 5/14/2013

View of levee crown looking upstream at crossing.

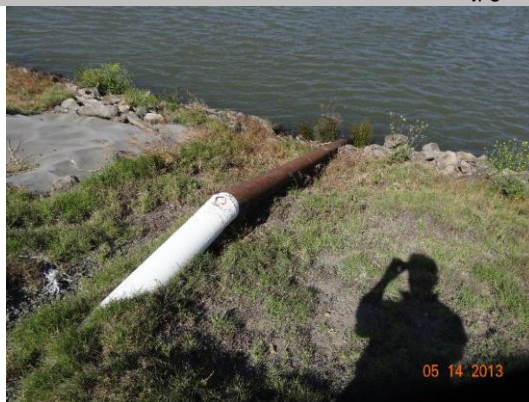
Photo 3 of 3 : UCIP_SP_2017_19545_33171.jpg

View of crossing on waterward slope. Rip rap present at waterward toe.
